TRUXEDO® DEUCE UNDERBODY SEAL UPGRADE

P/N 1117094 Rev. C

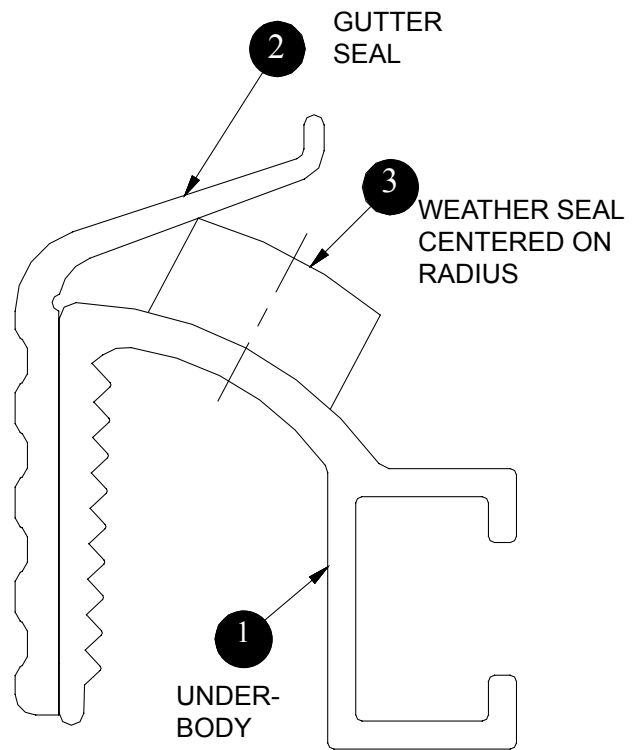
END VIEW

Step 1

Remove seal (2) and (3).
Clean underbody rail.

Item	Part #	Description
1	1703850	Rail Front, Underbody
2	1703860	Extruded Gutter Seal (OLD)
3	1703085	Extruded Weather Seal (OLD)
4	1703942	Extruded Underbody Seal (NEW)

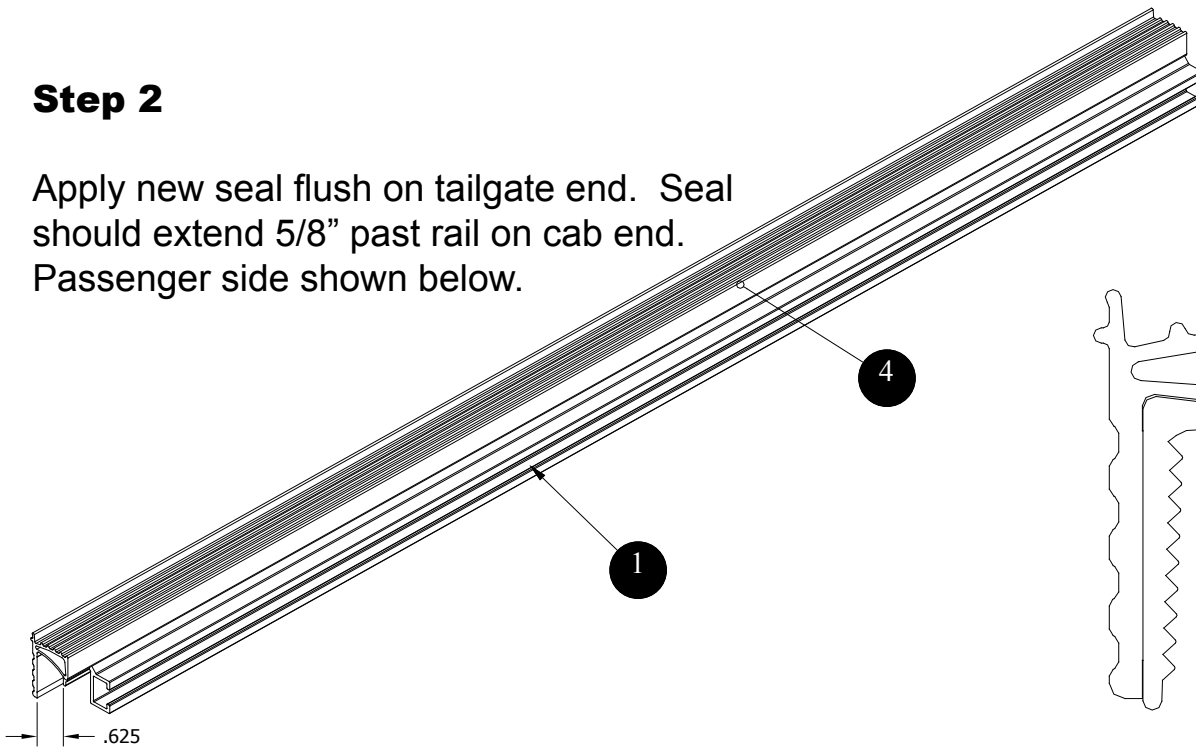
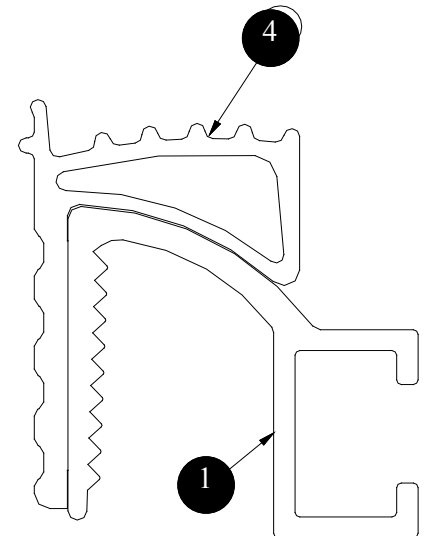
END VIEW

Step 2

Apply new seal flush on tailgate end. Seal should extend 5/8" past rail on cab end. Passenger side shown below.
